Manhole Inspection Summary

Manhole # S45CC_047MH

Insp Date: 7/1/08 11:34 AM

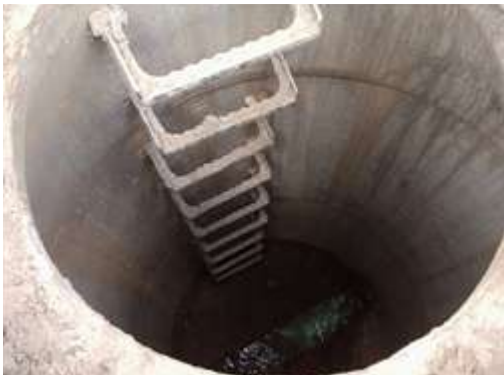
Defect 1

☒ **Leaks**

Frame Leaks

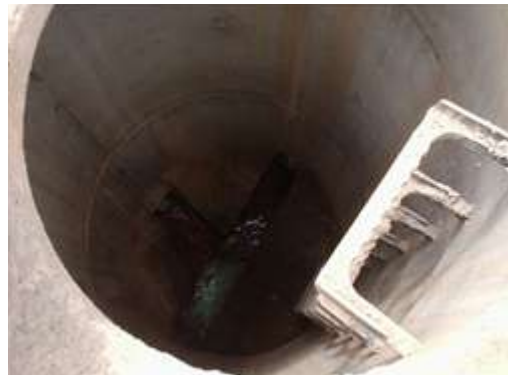
Defect 2

Infiltration: ☐ None ☒ **Joint** ☐ Cracks ☐ Mortar ☐ Roots ☐ Wall

Infiltration: ☐ None ☐ Joint ☐ Cracks ☐ Mortar ☐ Roots ☒ **Wall**

Infiltration

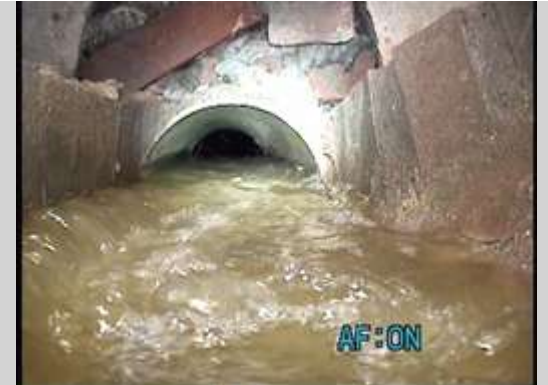
12 O'Clock Outflow

8 in. Circular Gravity Sewer
Pipe Out @ 12 O'Clock

Pipe Height: **8.4** (in.) Rod and Bar (Angled)
Pipe Material: **PVC** ☐ Pipe Lined
Invert Depth: **11.00** (ft.) Flow Characteristics: **Fast**
Deposits: ☒ None ☐ Mud ☐ Sludge ☐ Debris ☐ Grease
Silt Depth: (in.) Deposits Extent:
Infiltration: **None** Pipe Seal Cond: **Sound**

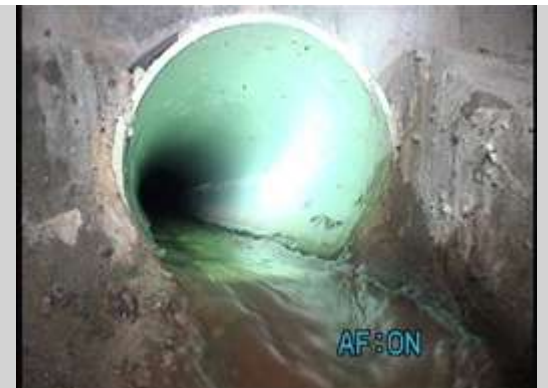
3 O'Clock Inflow

8 in. Circular Gravity Sewer
Pipe In @ 3 O'Clock

Pipe Height: **8.4** (in.) Rod and Bar (Angled)
Pipe Material: **PVC** ☐ Pipe Lined
Invert Depth: **10.55** (ft.) Flow Characteristics: **Fast**
Deposits: ☒ None ☐ Mud ☐ Sludge ☐ Debris ☐ Grease
Silt Depth: (in.) Deposits Extent:
Infiltration: **None** Pipe Seal Cond: **Sound**

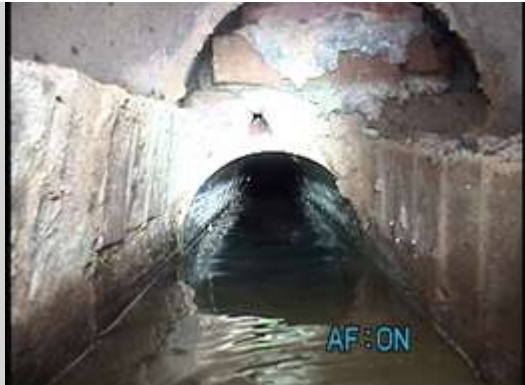
6 O'Clock Inflow

8 in. Circular Gravity Sewer

Pipe In @ 6 O'Clock

Infiltration: **None** Pipe Seal Cond: **Sound**
